Reliability Analysis, High Voltage Plastic Capacitors

TRW Capacitors began development of a High Voltage Capacitor (2KV thru 16KV), metallized polyester dielectric, in 1970. During the following three years the applicable volts/mil stress, design configurations, parameter limits, and environmental capabilities were fully explored and proven. Prior to the general release of a 'High Voltage Capacitor' catalog line, the single remaining question was RELIABILITY. During February of 1974, TRW Capacitors contracted with Ogden Technology Labs, Fullerton, California, to perform a D.C. Matrix Reliability Test on the subject capacitors. This report is a summary of the 10,000 hour data completed in April of 1975.

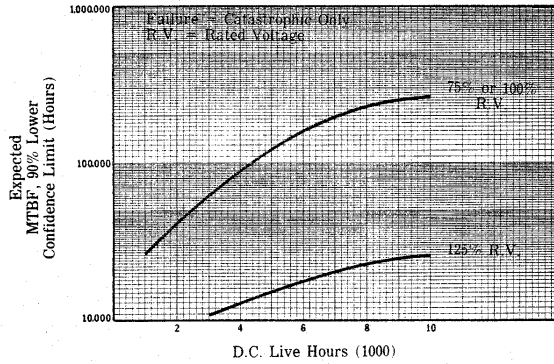
MTBF vs. Life

No catastrophic failures at either 75% or 100% of rated voltage occurred during the 10,000 hours of test (See Appendix A). This data indicates a MTBF (90% confidence limit) of greater than 260,000 hours at applications of rated voltage or less. Thirteen (13) catastrophic failures occurred at 125% of rated voltage (See Appendix A). This data indicates a MTBF of greater than 26,648 hours at applications of greater than rated voltage (See Fig. 1).

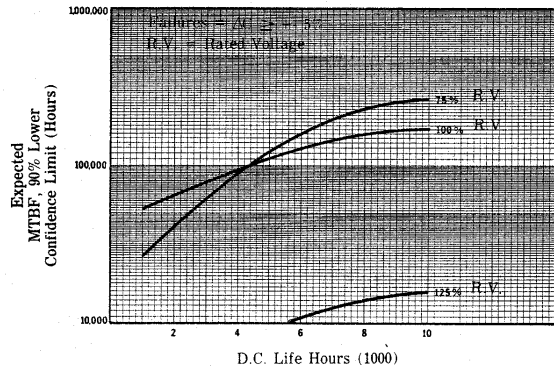
MTBF vs. Time

The changes at 75% and 100% of rated voltage (less than -1%) appear normal; however, -34% capacitance change at 125% rated voltage indicated further analysis of this potential failure mode was required (See Appendix B). Following this analysis additional failure criteria of +5% and +10% capacitance change were established, and new failure criteria was established (See Appendix A). The new failure criteria does not significantly effect MTBF at 100% R.V. or less; however, at stresses greater than 100% the MTBF begins to be degraded. A capacitance change criteria of +5% is consistent with most military and industrial requirements; hence, the plots in Figures 2 and 3 have not included the +10% of criteria.

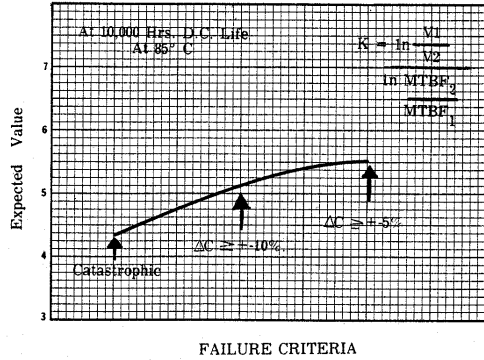
"K" vs. Failure Criteria

which states that one would expect the MTBF ratios and voltage stress ratios to behave as the 5th power. The data was examined for values of "K" under different failure criteria (See Appendix A). It was expected that "K" should fall in the range 5 to 7. The data behaved as expected (See Fig. 4).
